CONSUMER NEWS®

APRIL 2015

RIDING GEAR: Crash-Tested—and Repaired

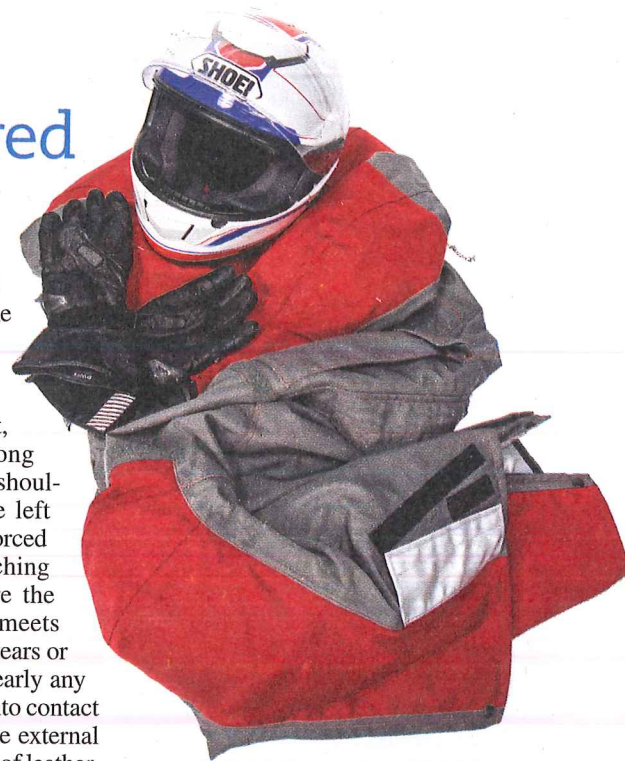
Aerostitch R-3 textile suit. My head slammed into the pavement during the initial fall and bounced at least once, striking the left temple region of the shell and carving a chunk out of the faceshield. With my left side taking the brunt of the impact, the Aerostitch suit made strong asphalt contact along the left shoulder, upper arm and elbow, the left hip area, left knee and the reinforced posterior. Apart from the stitching coming slightly undone where the bottom panel reinforcement meets the main shell, there were zero tears or rips. Finally, as is the case in nearly any crash, both of my palms came into contact with the ground, tearing into the external palm-heel armor and outer layer of leather. My \$199.95 Alpinestars CR-4 Gore-Tex boots kept my feet dry, but were otherwise untouched during the crash.

believed that a helmet is a one-use item, like an automotive airbag—no exceptions. But Shoei North America offers a full safety inspection process, conveniently located nearby in Tustin, California (more likely, you'd be sending your helmet in via the mail). To our eyes, the shield was toast, but the outer shell wasn't severely damaged. Internally, the critical Expanded Polystyrene (EPS) impact liner looked unblemished, but damage is often impossible to see, as an impact can result in damage between the outer shell and the EPS, hidden from view.

Shoei's technical experts pull your helmet apart and examine it in detail, looking for any reason its safety may be compromised. A cynic would say this system is designed to reject helmets in order to drive new sales, but according to the staff at Shoei, they actually approve approximately 50% of the helmets they run through their inspection process. They also noted that most helmets that fail are quite obvious, with massive shell damage or deformation (these severely damaged Shoeis are often sent back to Shoei Japan for analysis and research). In any case, my GT-Air passed with flying colors—despite the good knock it received, the shell was barely scratched, and the EPS was in perfect shape. The GT-Air is a DOT-only helmet, which some riders believe is not as protective or durable as a SNELL helmet; in this case, at least, it proved more than adequate for the task of saving my life, as that double temple hit would've likely been the end of me sans helmet.

inspection and is safe to return into service, Shoei returns each helmet to the customer with a confirmation letter. Turnaround for this service is typically 3–5 days from initial receipt of the helmet, and the only cost to the consumer is the initial shipping to Shoei's office. My GT-Air is back in service, and will likely remain so for several more years to come.

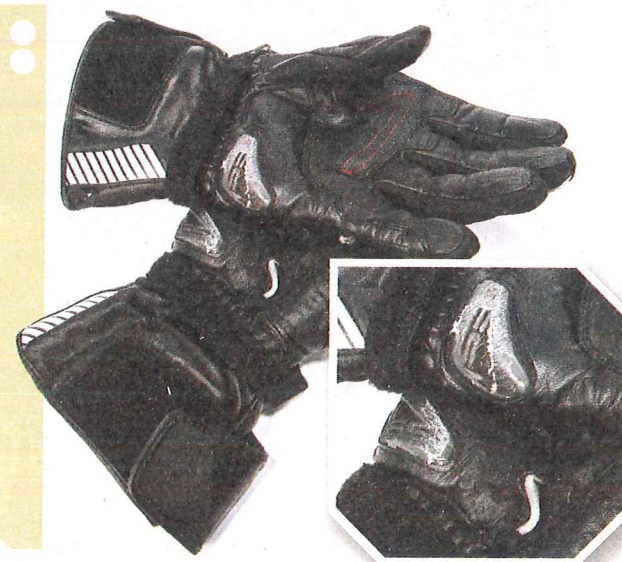
Finally, while there's little in the way of repairs available for gloves, it is worth noting lessons from the damage we found on the Rev'It Phantom GTXs. For one thing, this crash proved that you should never skimp on gloves, and that lightweight, MX-style gloves are next to useless. Despite being a waterproof touring glove, the Phantoms use racing-style rigid TPU armor inserts across the top of the knuckles, many of which took a decent hit from both impact and sliding during

the FZ-09 crash. More importantly, the Phantoms use a dual-density hard slider on the palm-heel, sitting atop additional layers of leather and foam armor. In normal use, you never feel this beefy palm protection, but the crash proved its worth, as both hands showed severe damage to both the reinforced leather as well as the hard palm-heel sliders. Had they not been there, a single layer of leather would've not only failed, letting my skin contact the asphalt, the additional impact force might have resulted in a broken wrist bone or two. Go look at the gloves you wear on a day-to-day basis—if they don't have some sort of hard palm protection, multiple leather layers, and some sort of sliding surface built-in, throw them out and get your hands into something safer.

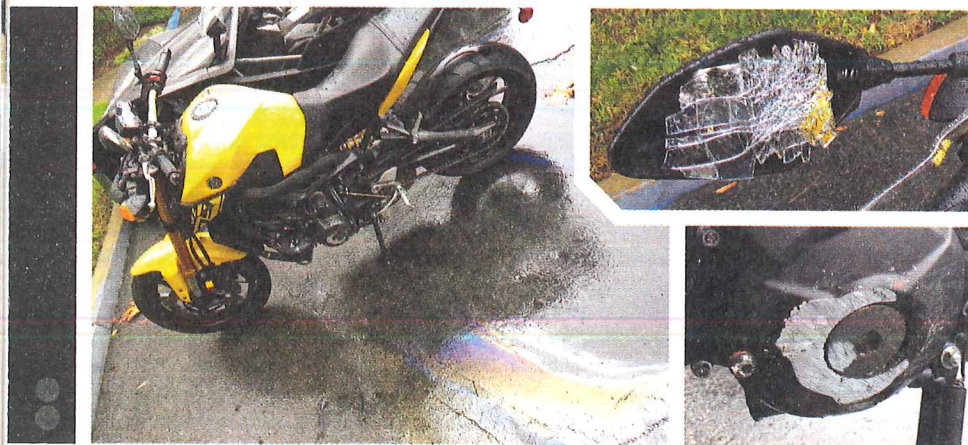
left-side controls, and dinging the metal fuel tank. Despite a pinprick oil leak in the engine cover, it was still fit to ride. The crash resulted in somewhere between \$300 and \$800 worth of damaged parts.
